Belt Conveyor for Injection Machine

Belt Conveyor for Injection Machine Introduction

Liftable conveyor Belt

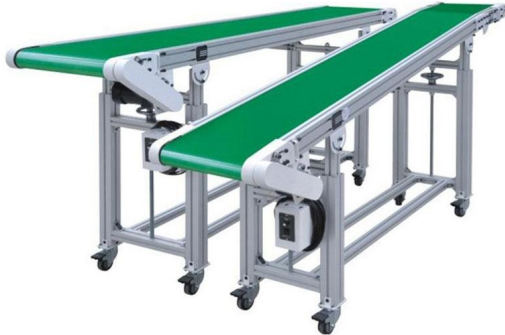
Belt Conveyor for Injection Machine
Description 1. Conveyor line (pre-embedded nuts for fixing have been placed inside) 2. Lifting adjustable movable tripod (pre-embedded nuts and screws required for fixing have been placed) 3. Crossbeam (the corner pieces, embedded nuts and screws needed for fixing have been placed)
