TEST REPORT

Client Name	Shenzhen TPH Technology Co.,Ltd
Name of product	Electric Breast Pump
Manufacturer	Shenzhen TPH Technology Co.,Ltd
Model	----
Test sort	Commission Test

Item Requested	Bisphenol A
	Standard/ Foundation	With reference to EPA 3550C:1996 and EPA8321B:2007, Analysis was performed by HPLC
	Conclusion	See test result page(s).
Note	This report is the English version of report No. SET2019-14865

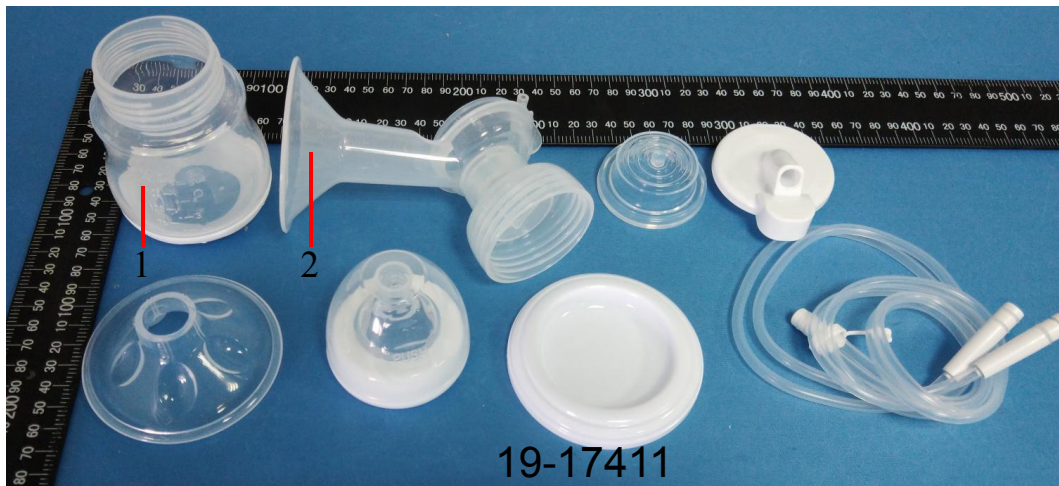
Sample Photo:

Specimen No.	Components Description	Color and Material	Item
1	Electric Breast Pump	Transparent PP	Bisphenol A
2		Transparent silica gel
